NO: SD-SC-006

SAFETY DIRECTIVE -MANDATORY-

MODEL AFFECTED:	SPORTCRUISER
SUBJECT:	FUEL CELL FINGER STRAINER – INCORRECT SEALANT USED
ASSEMBLED AIRCRAFTS AFFECTED:	07SC038 (OC4275), 07SC041 (OC4281), 07SC044 (OC4282), 07SC046 (OC4329), 07SC050 (OC4239), 07SC061 (OC4334), 07SC062 (OC4335), 07SC064 (OC700203), 07SC067 (OC4336), 07SC071 (OC4363), 07SC073 (OC4399), 07SC074 (OC3930), 07SC075 (OC3933), 07SC077 (OC700212), 07SC081 (OC4369), 07SC082 (OC700254), 07SC084 (OC3987), 07SC085 (OC3988), 07SC109 (OC3934), 08SC088 (OC700180), 08SC089 (OC4338), 08SC100 (OC700325), 08SC102 (OC700164), 08SC105 (OC700269), 08SC111 (OC700232), 08SC121 (OC4343), 08SC125 (OC700313), 08SC126 (OC700184), 08SC130 (OC4018), 08SC134 (OC700522), 08SC149 (OC700298), 08SC158 (OC4297), 08SC159 (OC700322), 08SC170 (OC700491), 08SC172 (OC700299)
KITS AFFECTED:	07SC037QBK (OC4074), 07SC048QBK (OC3837), 07SC049QBK (OC3855), 07SC057QBK (OC3857), 07SC092QBK (OC3853), 07SC097QBK (OC3945), 08SC108QBK (OC4007), 08SC113QBK (OC4010), 08SC120QBK (OC4012), 08SC122QBK (OC4311), 08SC127QBK (OC4006), 08SC138QBK (OC4041), 08SC145QBK (OC4027), 08SC151QBK (OC700466), 08SC153QBK (OC4188), 08SC154QBK (OC4131), 08SC165QBK, 08SC166QBK,

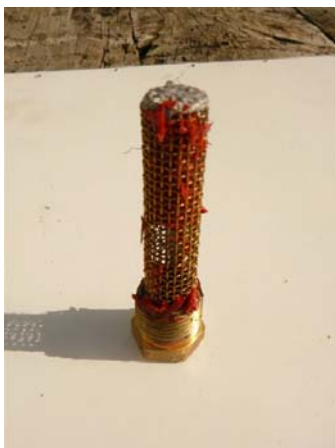
Picture 1 – finger strainer

Application of incorrect sealant of fuel cell outlet was found out (See picture 1,2). Used sealant is not intended to permanent contact with gasoline and may degrade. It can cause fuel leaks, corruption of fuel flow meter, blockage of finger strainer or gascolator screen, low fuel pressure and at the worst case engine stop. Was found out that it may occur in aircraft S/N defined above.

1. Remove inspection cover in wing bottom area close to wing root, both wings. (Picture 3)
2. Check color of sealant that could be visible around the thread of finger strainer and fuel fitting. If it is white (light gray), then the SD is done. Install inspection covers and annotate aircraft records to reflect compliance with this safety directive.
3. If the sealant is red (orange,brown), or there is not visible sealant, or there is uncertainty about sealant color, continue to **Step 2**.

1. Ground aircraft.
2. Remove engine cowlings.
3. Disconnect battery.
4. Drain fuel system, open fuel caps and let vapor ventilate.
5. Disconnect fuel hose from fuel outlet brass fitting (Picture 4).

6. Remove brass fitting and finger strainer from fuel cell, disconnect brass fitting and finger strainer (Picture 5).
7. Remove drain valve from fuel cell.

8. Carefully clean sealant from brass fittings, finger strainers and fuel cell.
9. Rinse fuel cell by gasoline to clear debris away and let it dry. If necessary, clean debris by vacuum cleaner.
