SAFETY DIRECTIVE -MANDATORY-

NO: CZAW-SD-SC-009

MODELS AFFECTED: SPORTCRUISER: All SLSA Sport Cruisers and Experimental Kits built under Czech Aircraft Works (CZAW).

SUBJECT: SEAT BELT SHOULDER HARNESS REPLACEMENT

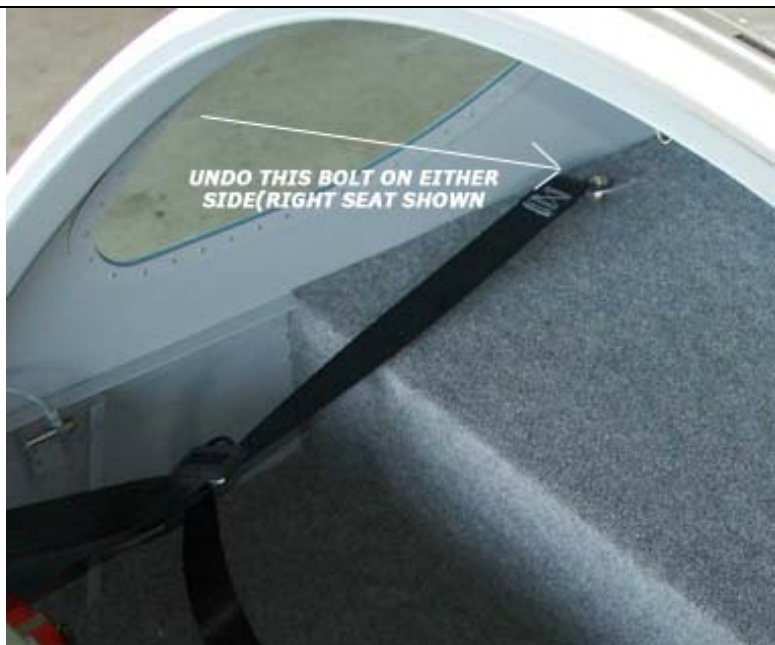
Figure 1

1. Three (3) bolts are used to secure the seat-belt shoulder harness to the airframe on each side. Uninstall all the attachment bolts that secure the existing harness from the airframe. One can start by removing the rear attachment bolt of each harness, located in photo Figure 1.

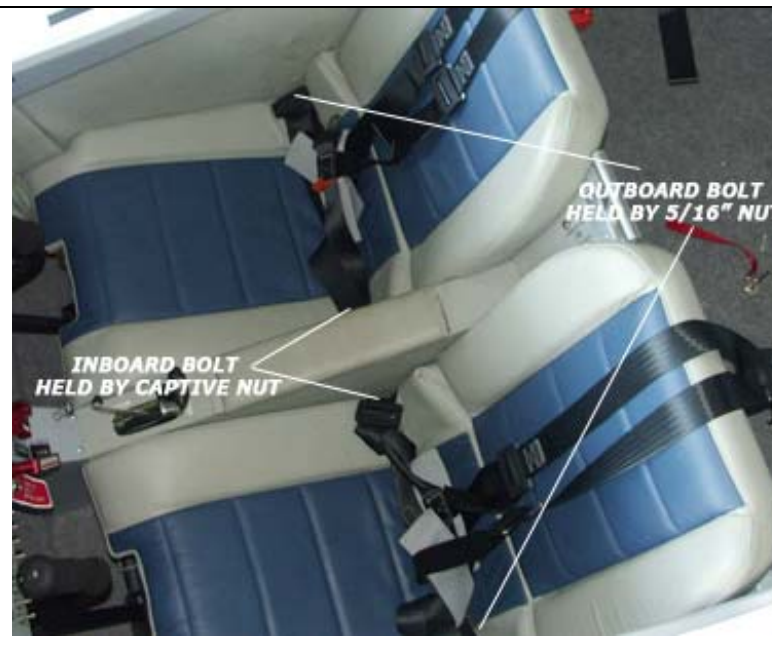
Figure 2

2. Next remove the inboard lap belt bolt, located in photo Figure 2. This bolt is held with a basket nut for easy removal.

3. Removal of the outboard lap belt bolt located in photo Figures 2-3 will be the most difficult nut and bolt to remove since its fastener nut is located in the vicinity of where the wing attaches on the outside area of the airframe. Take a moment to review installation photos. Photo Figure 3 shows the location of a small access hole that must be cut from the lower wing skin. Great care must be taken to gently remove the glue attaching the rubber seal that runs along the edge of the wing skin. This can be done with a sharp plastic scraper and inserted just enough to reveal the inboard edge of the skin. Cut the glue away until you can push the rubber seal to allow access for the next operation of cutting the skin.

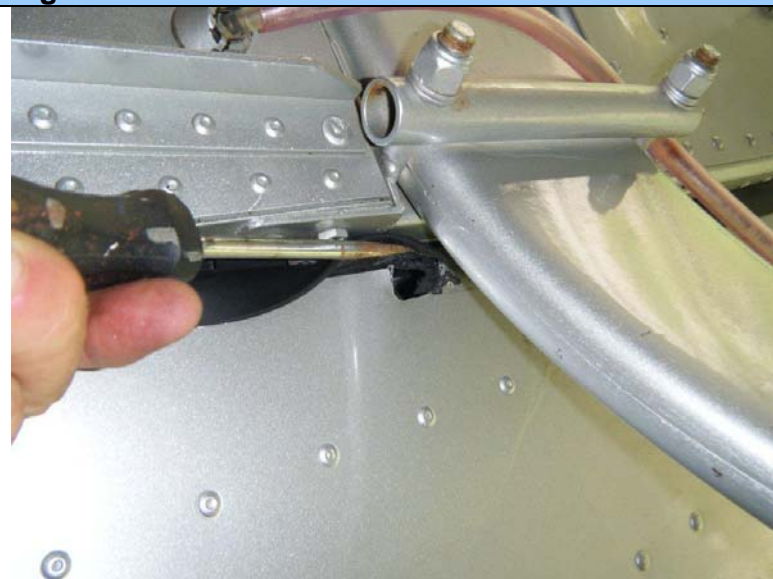
4. Mark a small rectangular pattern 7/8" long and no wider than the rubber seal. Use a small grinding rotary file to slowly remove the outlined metal for best results. Pay close attention while grinding the skin not to protrude too far into the wing cavity as this could damage wires or other equipment. After cutting the rectangular hole, remove any burrs that have formed along the cut edges. This hole should now allow access to the 5/16" nut holding the seat-belt nut fastener. Photo Figure 4 shows the access opening after cutting the access hole.

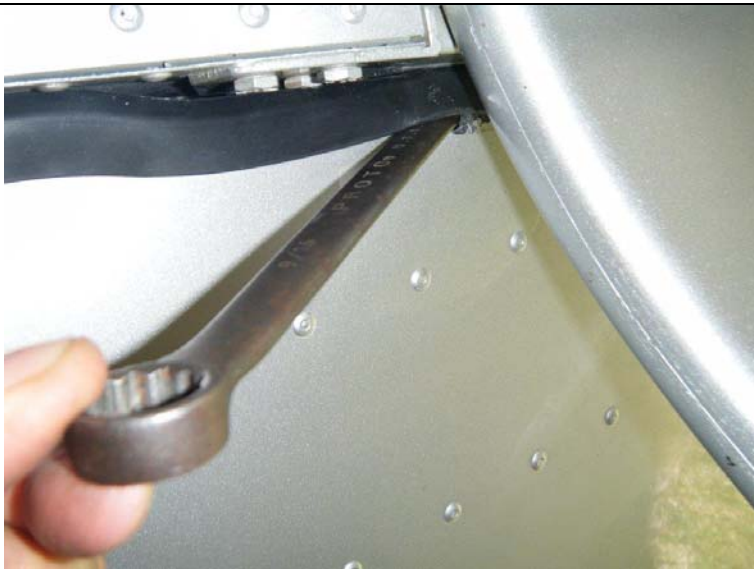
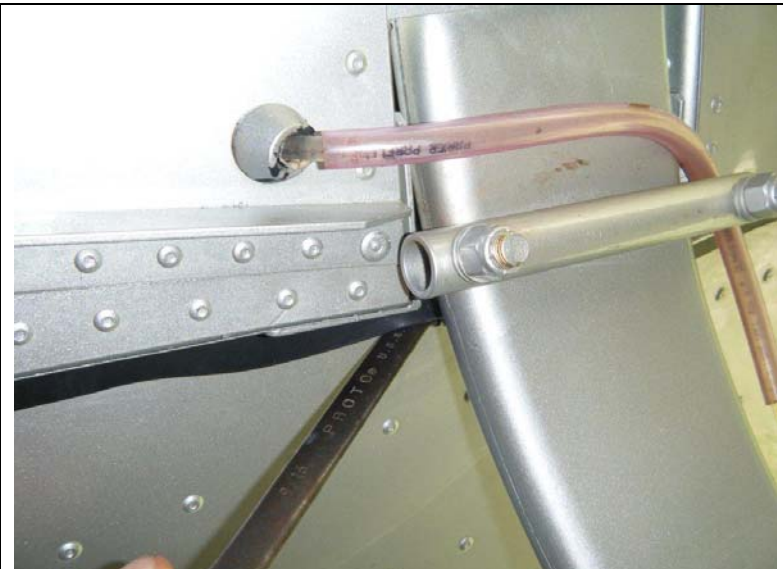
5. Photo Figures 5(a) and 5(b) shows the wrench inserted into the hole for nut removal. A small piece of tape placed over the box end of the wrench should allow you to capture the nut for removal. Photo Figure 6 shows this method which is the best way to capture the nut.

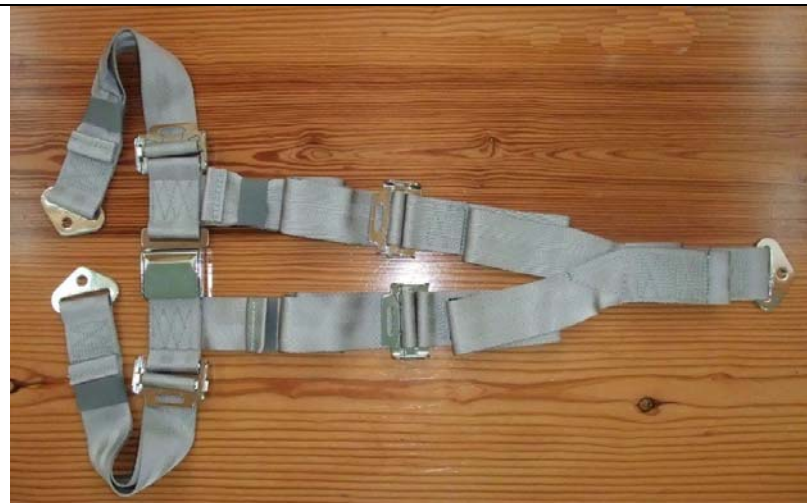
Figure 7

6. Prepare the new seatbelts shown in photo Figure 7. **NOTE TO INSTALLER:** Only seat belts with the part number CZAW 2894 are approved for this Safety Directive as this part has been guaranteed and approved to be constructed using TSO c-22-f as a basis for its design, construction and testing. Refer to photo Figure 8 for label description and part authenticity verification. No other seat belt shoulder harness restraint system may be used to fulfill the obligation of this Safety Directive under any circumstances.

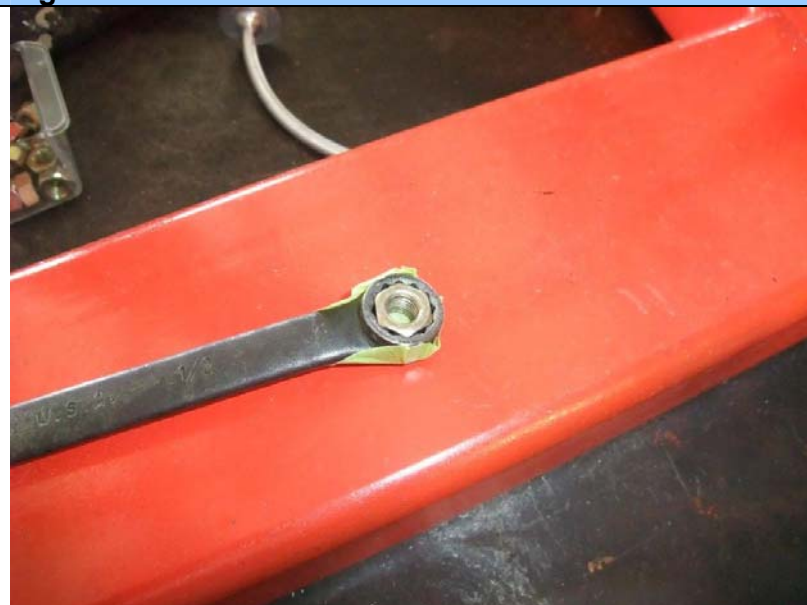
7. Photo Figure 9 shows the new nut going back with a piece of tape holding it in place.
8. Reinstall all bolts with **NEW** nuts in original positions.
9. Reattach rubber seal with clear RTV or contact cement.
10. Make log book entry. This safety Directive must be carried with and accompany the Maintenance logbooks at all times. Failure to so will be in direct violation of the stated rules set for the by the FAA.
